Sewage Pump Overhaul

Industry: Water
Product: Corroglass 600 series
Expertise: Repairs and Rebuilds

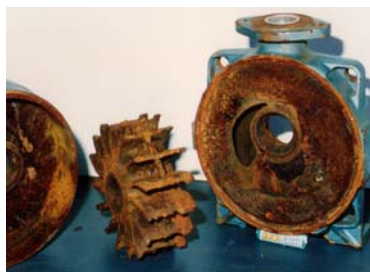
These sewage pumps were lasting 8 months and were being replaced on a regular basis. After a complete rebuild including new shaft, bearings and Corroglass 600 series coating the pump was put back into service and has operated for more than 10 years.

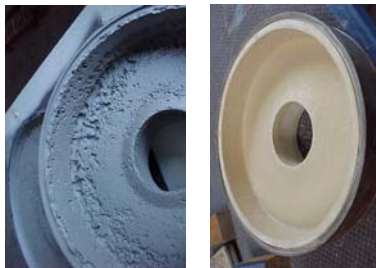
Warman Pump Casing

Severe Acid attack

On the left is the severely acid corroded casing with holes right through the casing. On the right the casing has been repaired and machined back to original dimensions with 600 series. Corroglass 600 series is suitable for protection against aggressive acid environments. The repairs were completed for a fraction of the replacement cost and the cause of the corrosion was eliminated.

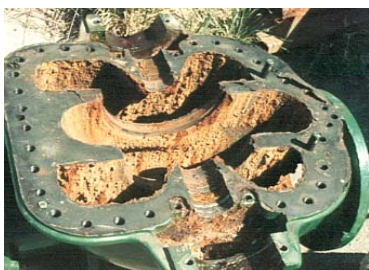
Worthington Pump

Severe corrosion, deep pitting and corrosion deposits resulted in poor performance, increased pumping costs and its untimely failure. All internals were rebuilt and re profiled using 600 series. The wear rings and landings were built up with Corroglass and machined to original size. A top coat of Fluigluid was applied to reduce friction and the savings in power consumption paid back the repairs in 15 months.

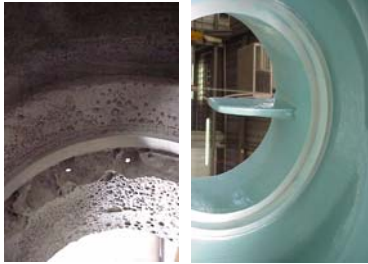
Condenser Water Pump

Severely Corroded Ajax Pump

Left is the pump inlet as we received it. Note the deep pits and holes in the casing. Right is the pump after repair and rebuild with Corroglass 600 series. The cause of the damage, corrosion, has been eliminated and the pump can be put back into service for many more years.

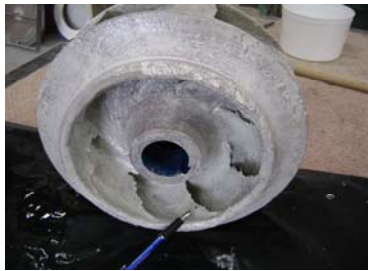
Sea Water Pump

This impeller has been blasted, treated for salt contamination and primed with one coat of Corroglass 600. Note the severely corroded impeller vanes. They were rebuilt using a composite of Kevlar matting and 600 series. After coating the impeller is balanced and Fluiglide is applied to reduce friction and increase efficiency.

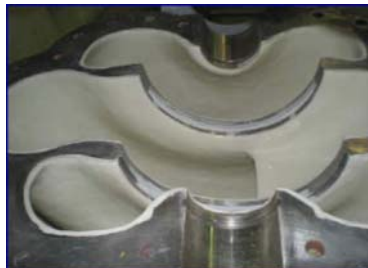
Fluiglide Treatment of 14/12 HSC Pump

Corrocoat regularly treat new pumps for the pump manufacturers. This pump was treated with 600 series to prevent corrosion, followed by one coat of Fluiglide which typically improves efficiency by 4-6%. An external coat of ZF is applied to provide corrosion protection to the exterior of the pump.

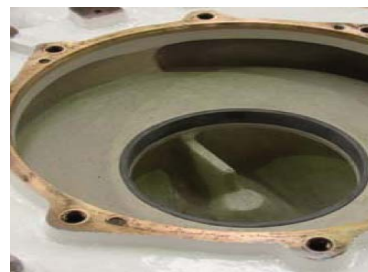
Refurbishment & Coating Hamworthy Pump Casing

Armigel is a durable coating offering excellent abrasion and chemical resistance. Armigel may be used on its own or as a top coat for Corroglass and Polyglass materials. This cast bronze pump casing was internally lined with 600 series followed by Armigel. Two coats of ZF were applied to the external of the pump casing.

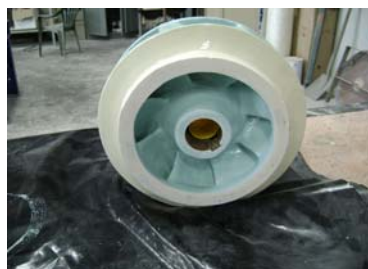
Sea Water Impeller

This bronze impeller was severely corroded from the sea water environment and required considerable rebuild work using 600 series and Kevlar matting. The outer faces of the impeller were coated with 200 microns of Fluiglide giving it a smooth finish thereby increasing the pump efficiency and reducing power consumption.
